GARVIES POINT REDEVELOPMENT PROJECT GLEN COVE, NEW YORK

DREDGE SPOIL CHARACTERIZATION PLAN

PWGC Project Number: RGI1508

OCTOBER 8, 2015

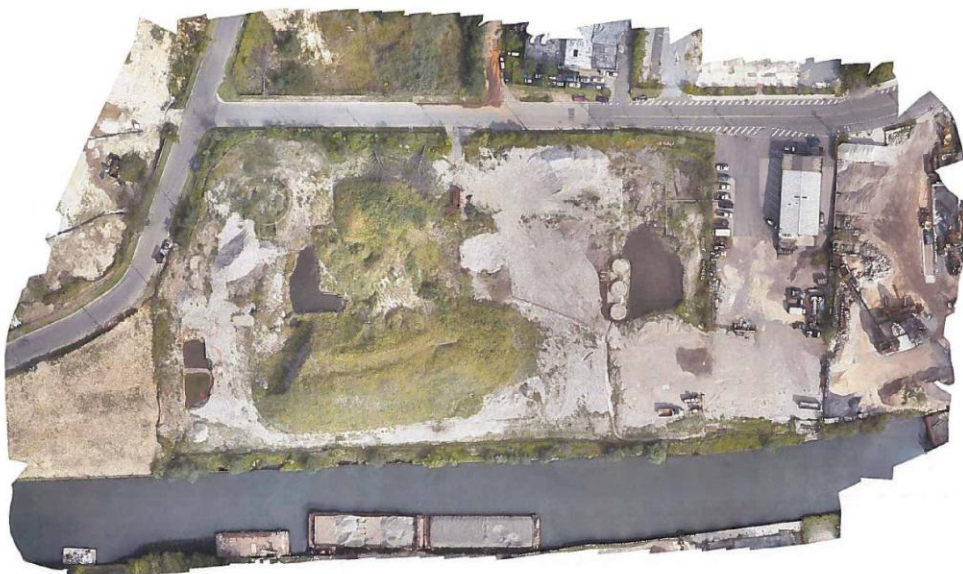
After the relocation of the dredge spoils to the central portion of Parcel A, a flyover survey was conducted to mark out the current location of the stockpile and estimate the overall volume of the stockpile. The survey estimated the stockpile at approximately 29,100-cubic yards which is comparable to the 31,400-cubic yards of spoils estimated to be removed between 2006 and 2007 less the 600 cubic yards approved by the NYSDEC for reused in 2014. A photo of the current stockpile is shown below.

The dredge spoil stockpile is currently located in the central portion of the former Li Tungsten's Parcel A. It is approximately 20 feet high and needs to have an access ramp created and flat areas graded to facilitate collecting samples from the top of the stockpile.

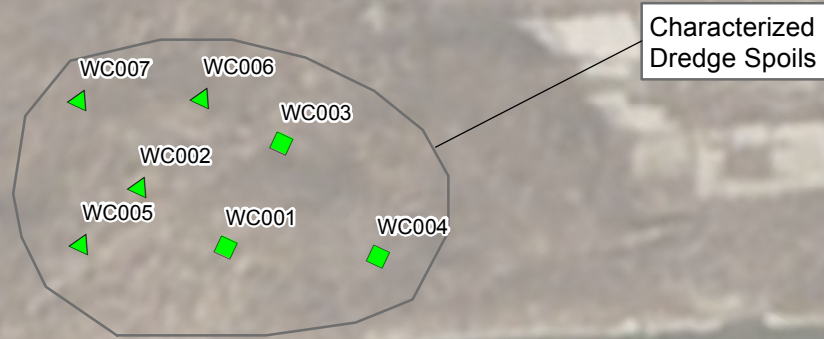
FIGURE NO:
2

- Composite WC008
- ▲ Composite WC009

- Backfilled Excavation
- Open Excavation

**DREDGE SPOILS WASTE
CHARACTERIZATION
SAMPLES (10/1/2014)
GLEN ISLE**

On October 1, 2014, the NYSDEC was asked to permit the reuse of dredge spoils as backfill in the areas where gross contamination was removed. Approximately 1,000-cubic yards of fill were estimated to be the volume needed to stabilize the pits. In order to determine if the dredge spoils were acceptable for reuse, PWGC collected samples from a portion of the northwestern dredge spoils area, representing 1,000-cubic yards, which had not yet been relocated to the central portion of Parcel A. The location of the dredge spoils and sample locations are shown in **Figure 2**. An excavator was utilized to collect representative soil samples from the stockpile in accordance with Table 4: Recommended Number of Soil Samples for Soil Imported to or Exported from a Site from NYSDEC's *Final Commissioner Policy, CP-51 / Soil Cleanup Guidance*. Samples were screened in the field for the presence of volatile organic vapors with a photo-ionization detector (PID). Volatile organic vapors were not detected in the samples collected. A total of seven grab samples (WC001 through WC007) were analyzed for VOCs (USEPA Method 8260) and two composite samples (WC008 and WC009) for SVOCs (USEPA Method 8270), metals (USEPA Method 6010/7471), pesticides (USEPA Method 8081), and PCBs (USEPA Method 8082). Analytical results were compared against the SWCLs, RRUSCOs, and previous characterization data. Analytical results were below either SWCLs or RRUSCOs and similar in concentrations to the 2007 characterization data for VOCs and SVOCs. Analytical results are summarized in **Tables 1, 2, and 4**, located to the right of the original 2007 data.

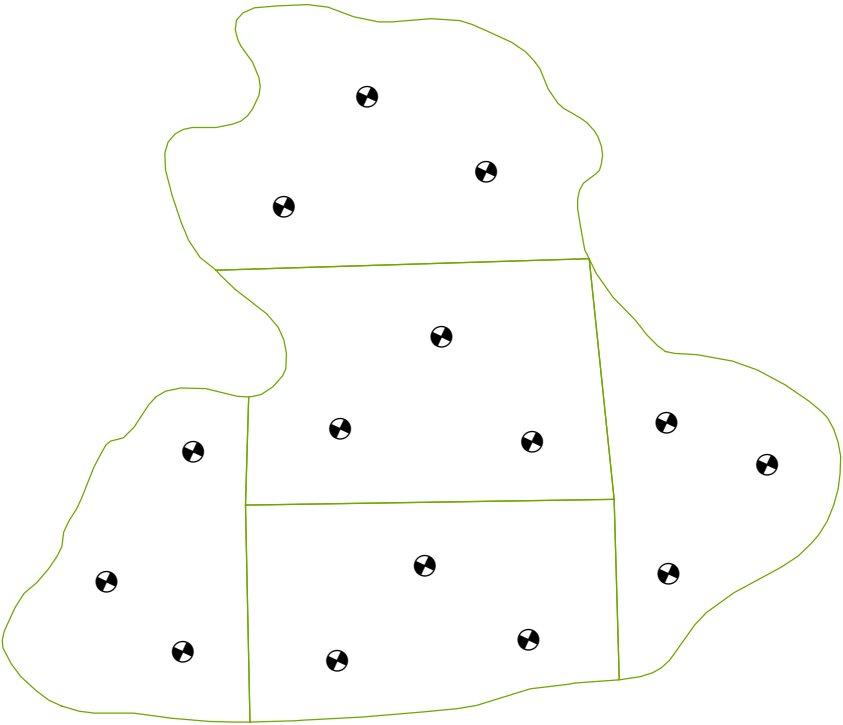
FIGURE NO:
4

- Proposed Waste Characterization Sample Locations
- Property Boundary
- Proposed Waste Characterization Grid
- Curblines

**PROPOSED
SAMPLING GRID**

In order to assure that the samples collected are representative from the entire dredge spoil stockpile aerially and vertically, PWGC proposes to divide the pile into five segments. Three borings will be installed in each segment. Elevations will be established for each soil boring location so that the depth from the top of the stockpile to the land surface can be determined. Once the elevations are determined, the segments will be divided into four depth intervals that coincide with equal elevations. This will result in a total of 20 independent vertical sampling locations within the dredge spoil stockpile representative of approximately 1,500 cubic yards.

The samples from each vertical sampling location will be composited and analyzed to describe its quality which conforms to the recommendations in the table from CP-51, above. In addition, this sampling/analysis plan will also produce separate results for the lowest horizon, which may be able to indicate if the bottom of the spoil pile has comingled with the residual soil, and if so, if this layer suitable for reuse. The sample grid pattern is shown in **Figure 4**.
